Technical Guidance Note 11

Cold Removal of railing fragments from sandstone cope.

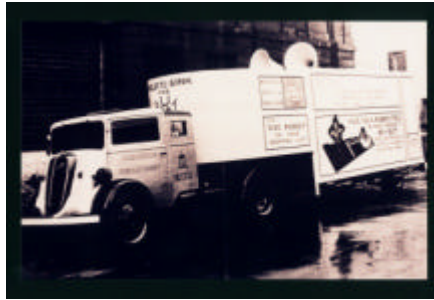
Railings removed for the war effort in Glasgow / typical detail

Removal of Iron railings for the war effort has left many cope stones with railing stubs intact set into tamped lead sockets. At between £3-500 per lineal metre for new cope, and with the aim of maintaining the historic fabric of the wall, this method provides a low – tech method for removal to allow a new installation.

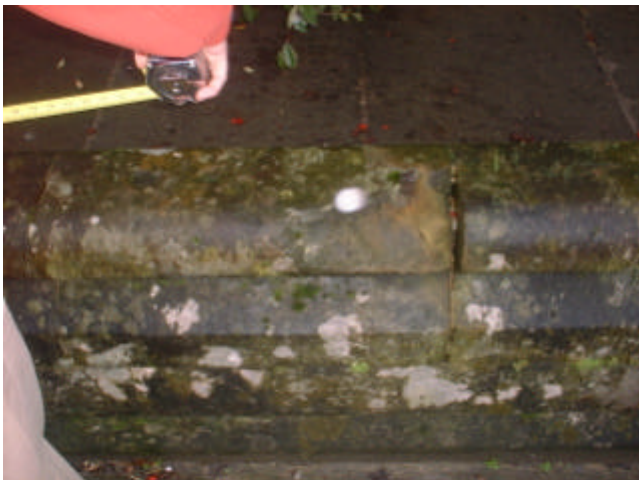
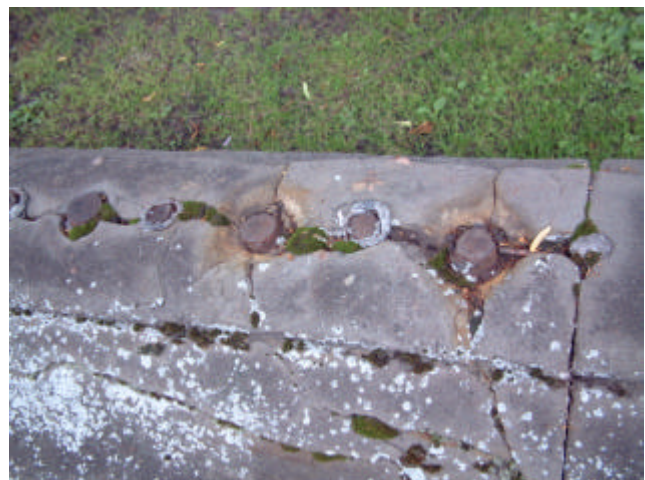
Existing cope, railings removed and stubs in – situ. Dungarvan

Heat should NEVER be used for the removal of stubs. The Health & Safety risks associated with melting lead in a public space are onerous, and wet copes can often explode as the water turns to steam and expands rapidly. Some copes are beyond saving however, as the sample to the right (above) shows.

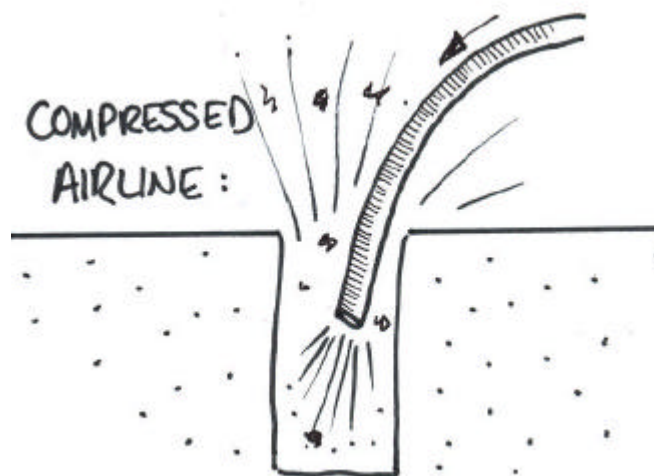
Stage Seven

An airline is used to clear any residual debris.
